PBY Catalina

Walk Around

By William Scarborough

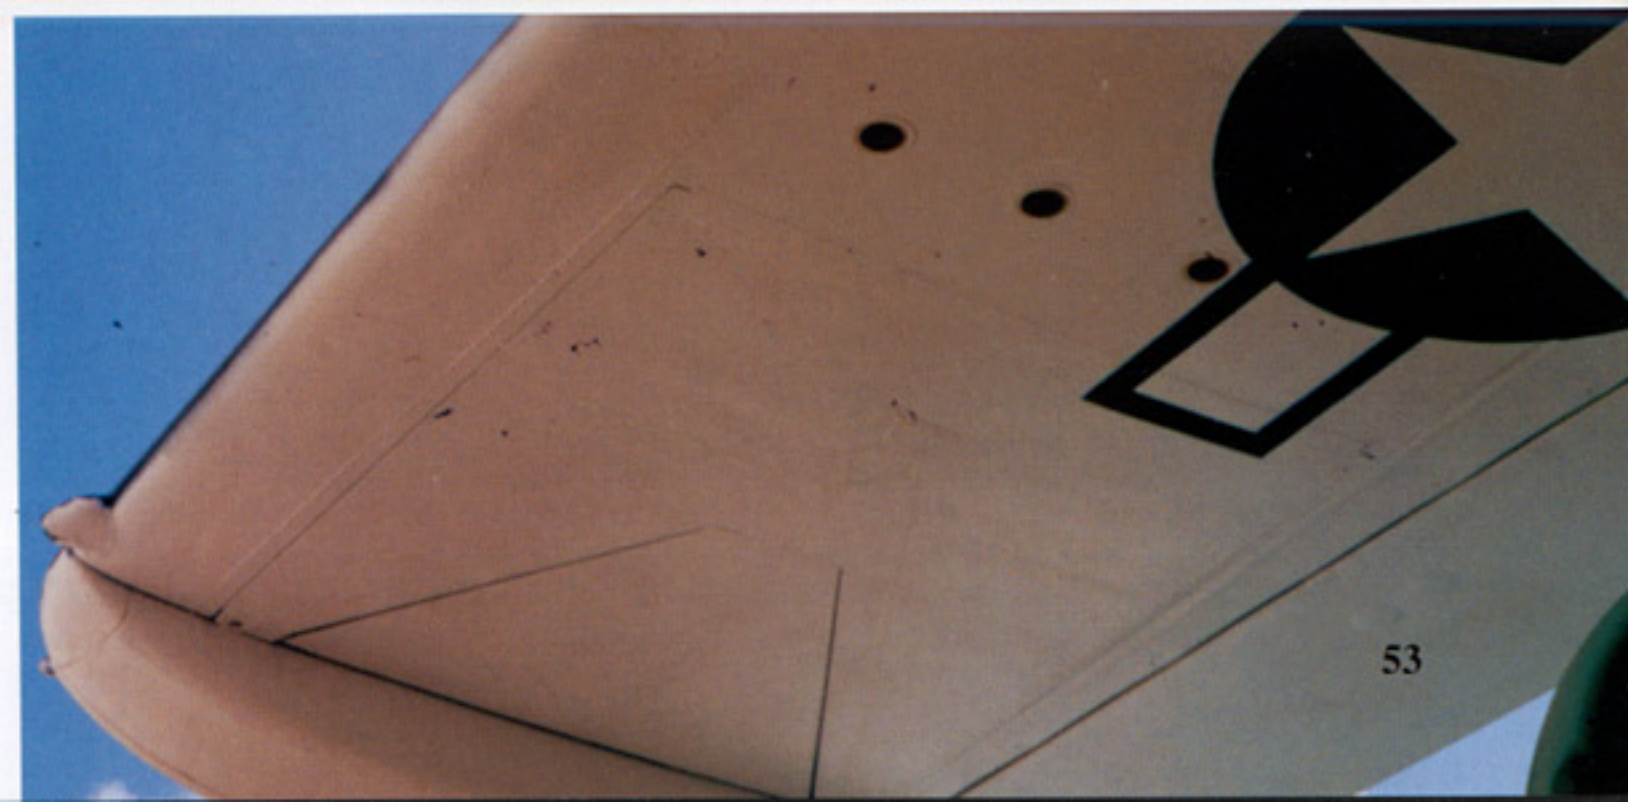
The starboard wing of a PBY-5A showing the three underwing recognition lights that were mounted just inboard of the retractable wing tip float. The lights were (from back to front) Red, Green and Blue. These lights were used for identification, displaying one of more lights in color patterns ordered by the area operational commander for specific time periods both day and night. (Richard Dann)

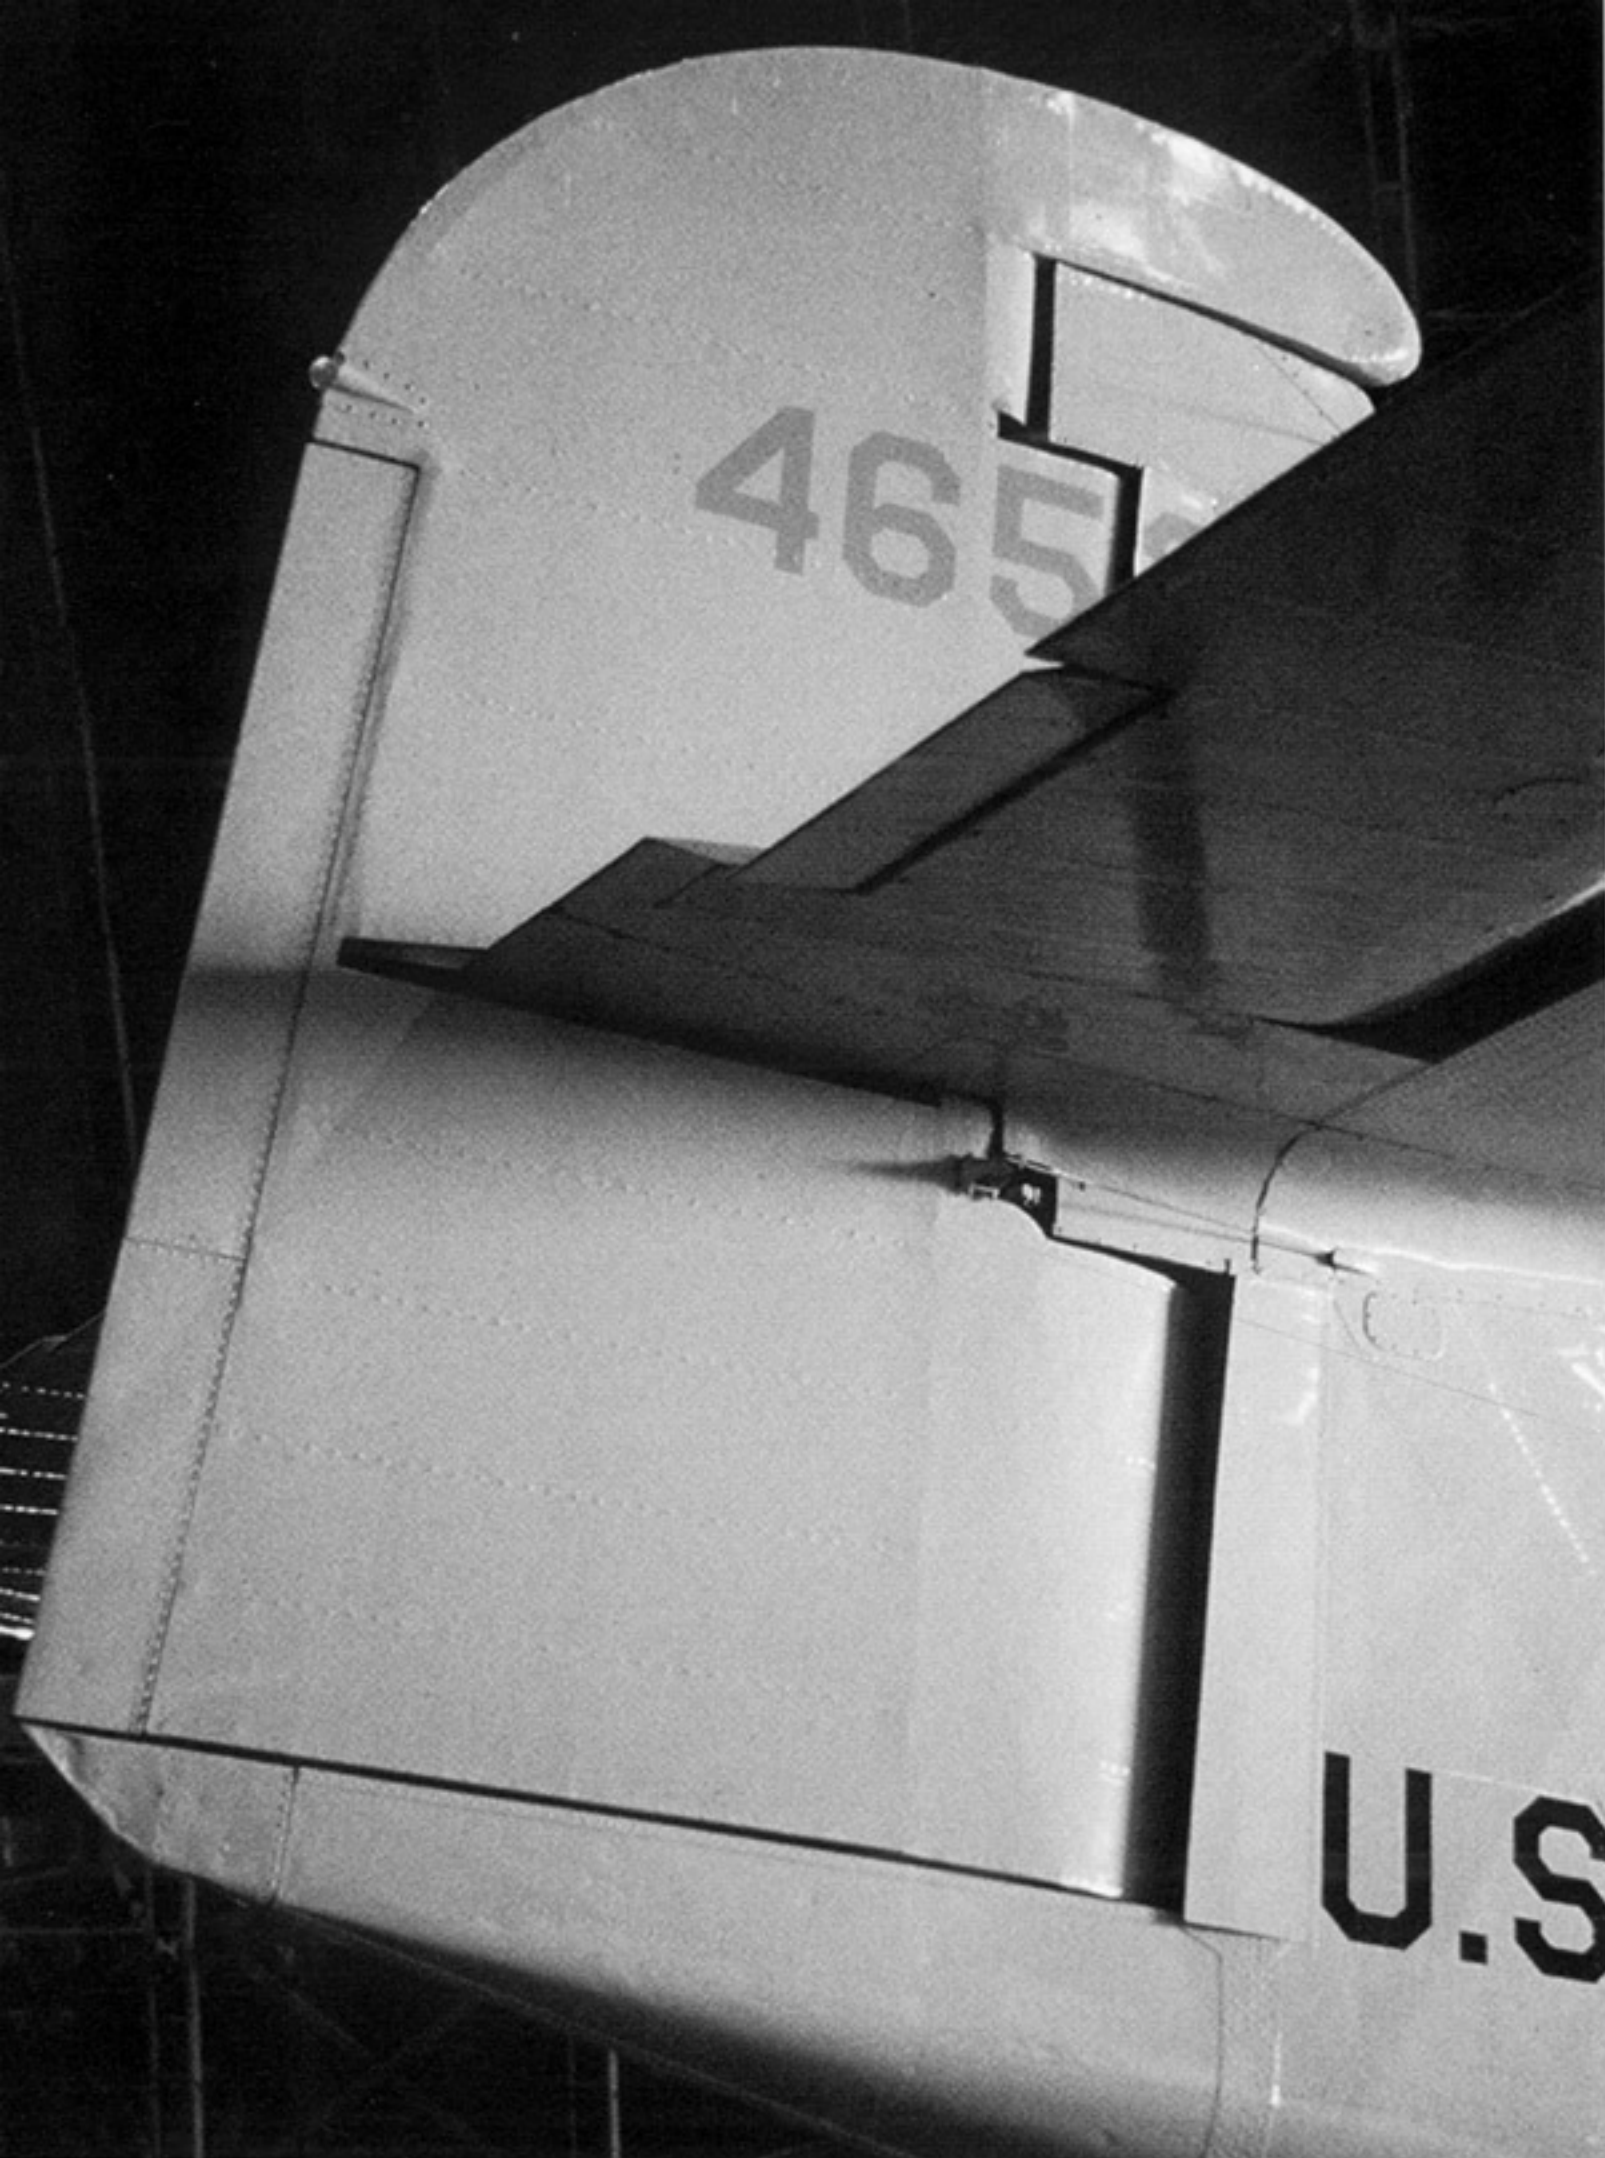
Side by side it is easy to see the differences in the fin and rudder area of the PB5A (left) and PB6A (Right). The PB6A had a three and a half foot taller fin and rudder. This tail modification was derived from engineering and wind tunnel studies which led to superior control responses on the PBN-1, these modifications were then incorporated into the PB6. The rudder balance forward of the hinge line on the PB5 was a post war civil modification intended to improve handling and reduce control forces. . (Mark Aldrich)

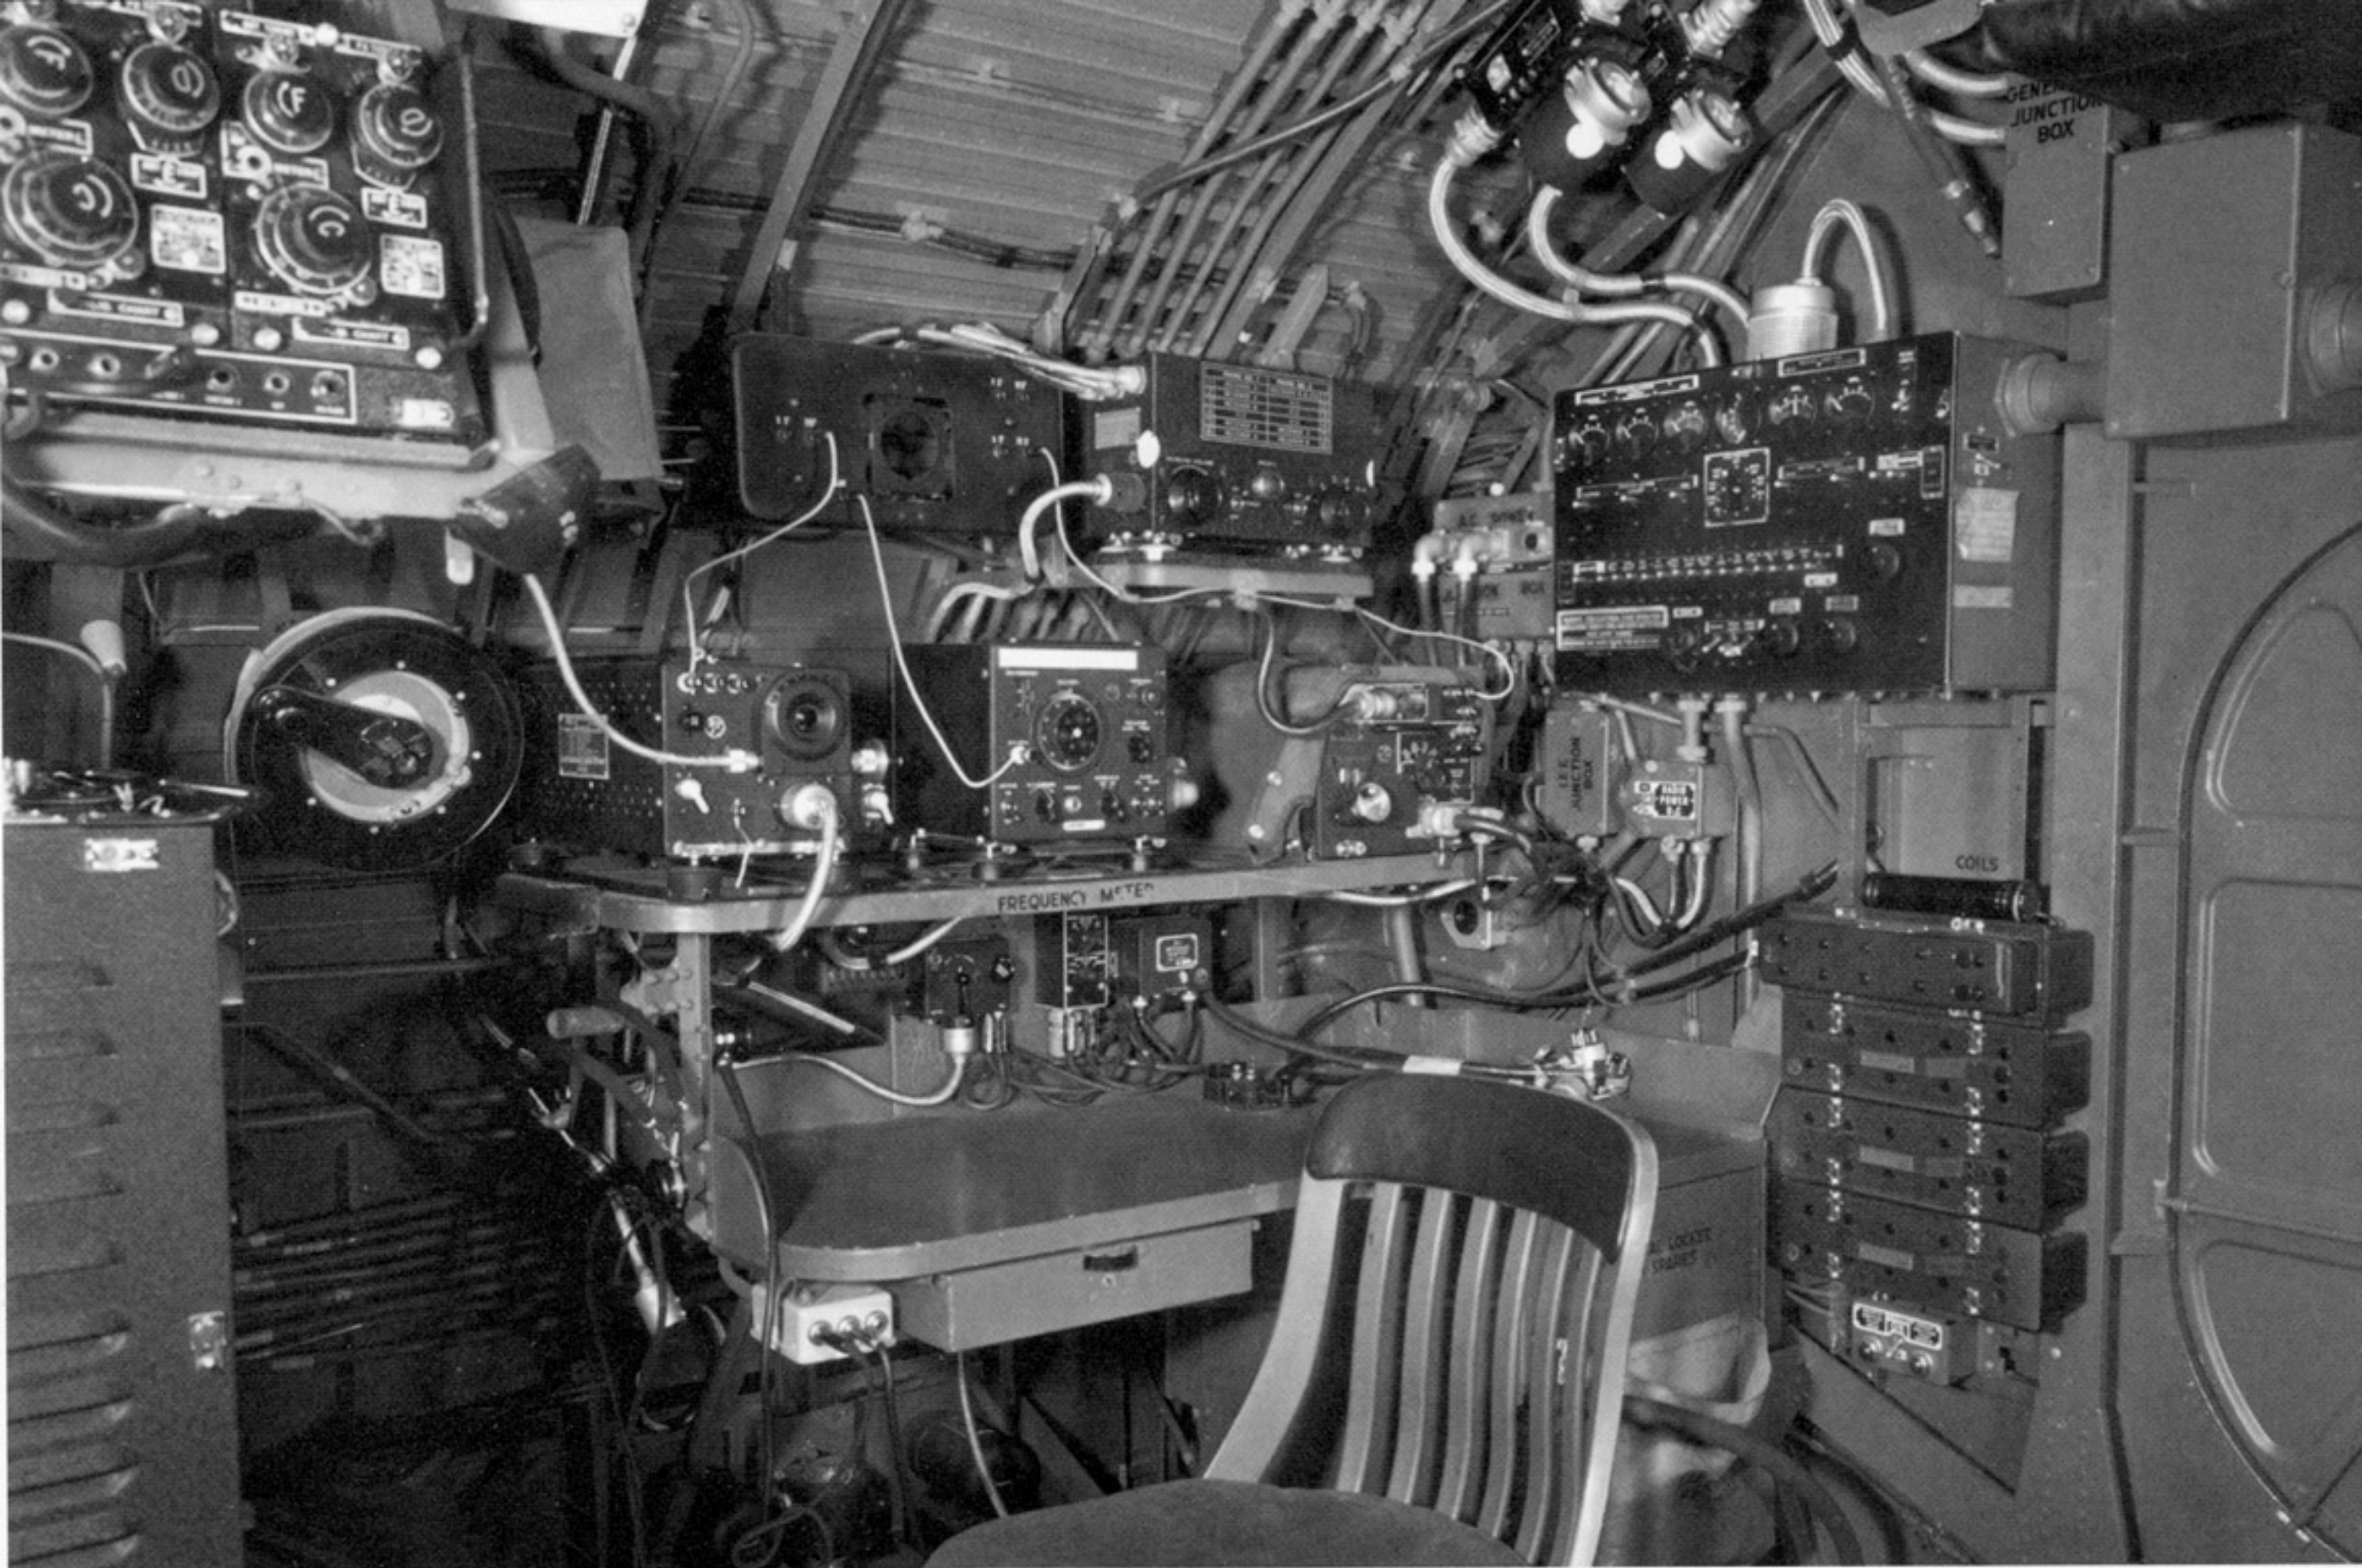
This PBY-5A at NAS Patuxent River, Maryland was equipped with the following radio gear in the radio/nav compartment. From left at the forward end of the compartment: GO-9 Transmitter with ATB Command Transmitter mounted above it. Antenna reel is to right. On the shelf above the radioman's desk are RV-19 Receiver, LM-10 Frequency Meter and ARB Receiver. Above them are Antenna Transfer and Clock panel and ICS Control Box. At upper right, mounted on aircraft structure, are two round bright end objects which are the Main Electric Power Distribution Panel. Below it are four coils which allow transmitter frequency changes. Continuing forward: radioman's desk with a storage locker at aft end with life jacket stowage pocket on its door and radioman's chair. On desk, under shelf, is the transmitter key, ZA Impedance Adapter, ARB Control Box and RU-19 Junction Box (bright connector on bottom. Below desk are ISC Dynamotor and Demolition switch. See pages 64/65 for additional details of radio gear. (USN)

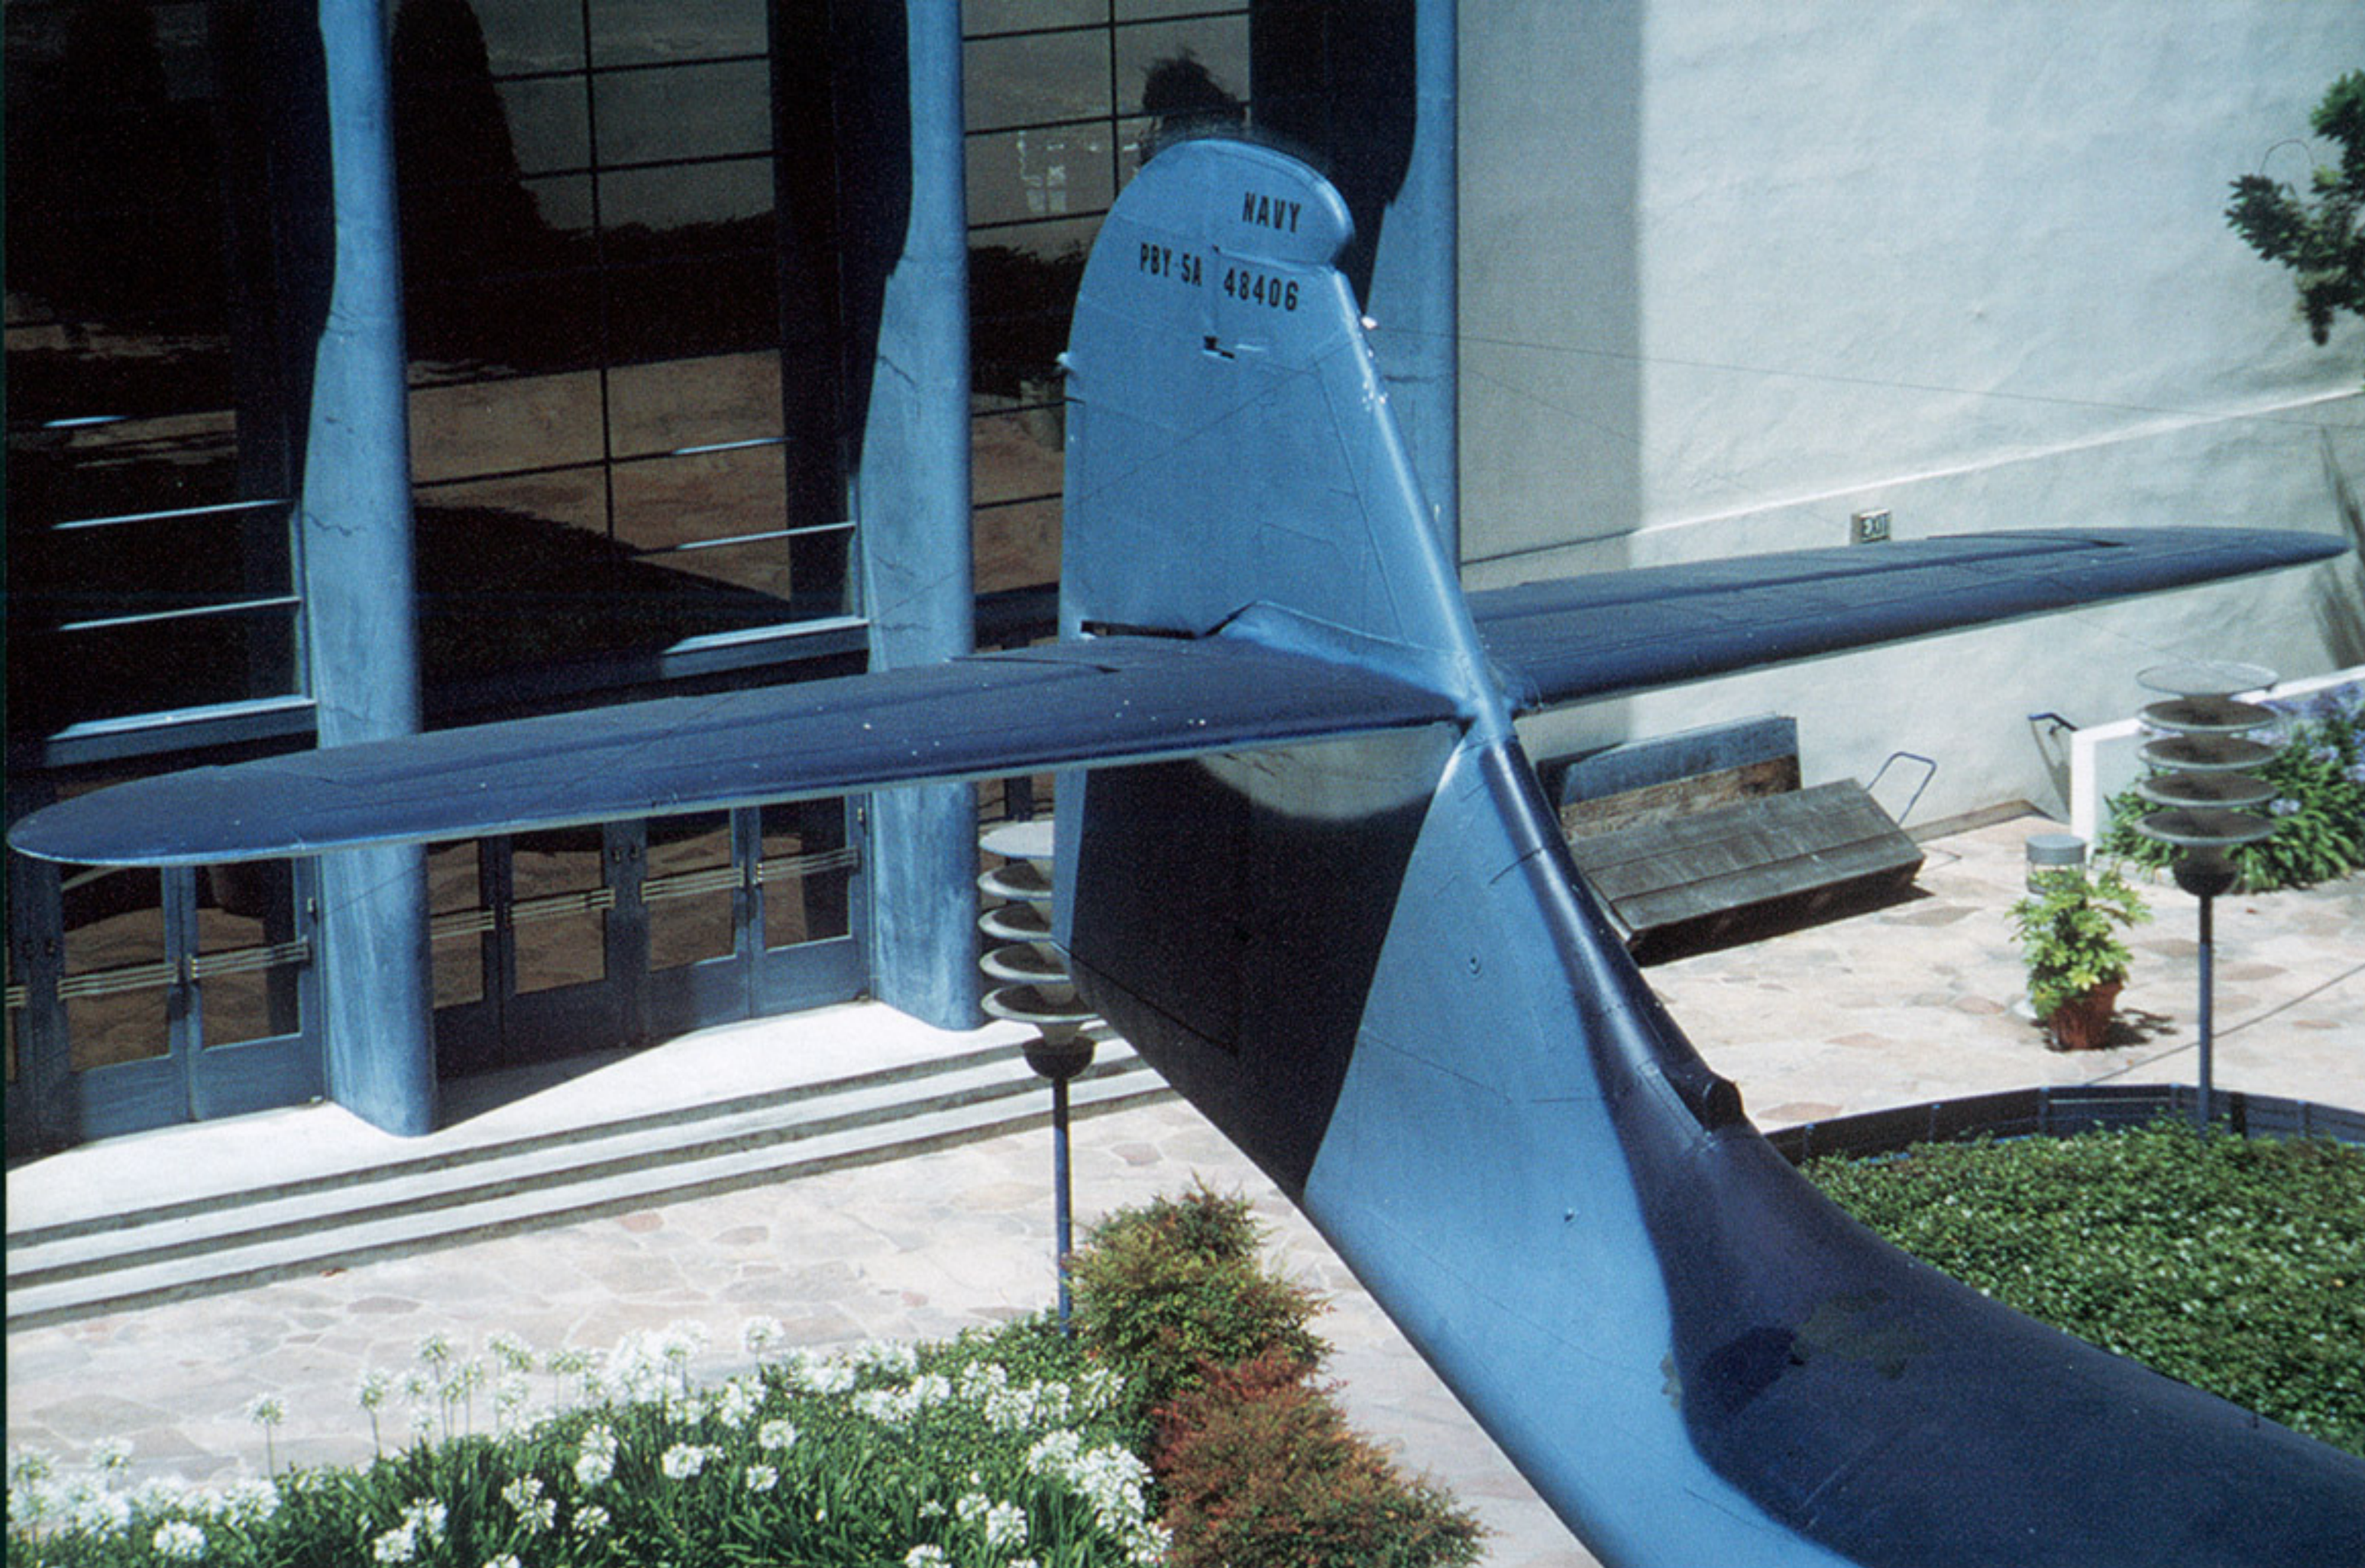
The vertical and horizontal stabilizers and control surfaces of the PBY-5A at the San Diego Aerospace Museum. The elevators are inset in the horizontal stabilizer and both are equipped with trim tabs. The round fairing just above the rudder trim tab is the tail navigation light. The small white object just below the tip of the fin on the forward edge is an antenna wire insulator. At least three antenna wires are attached to this insulator. The protrusion at the base of the fin is the air intake for the thermal deicing system. The rudder balance forward of the rudder hinge line reduced control forces and was not found on service PBY-5/5As. It was probably a modification installed by the previous civil owner. (Mark Aldrich)

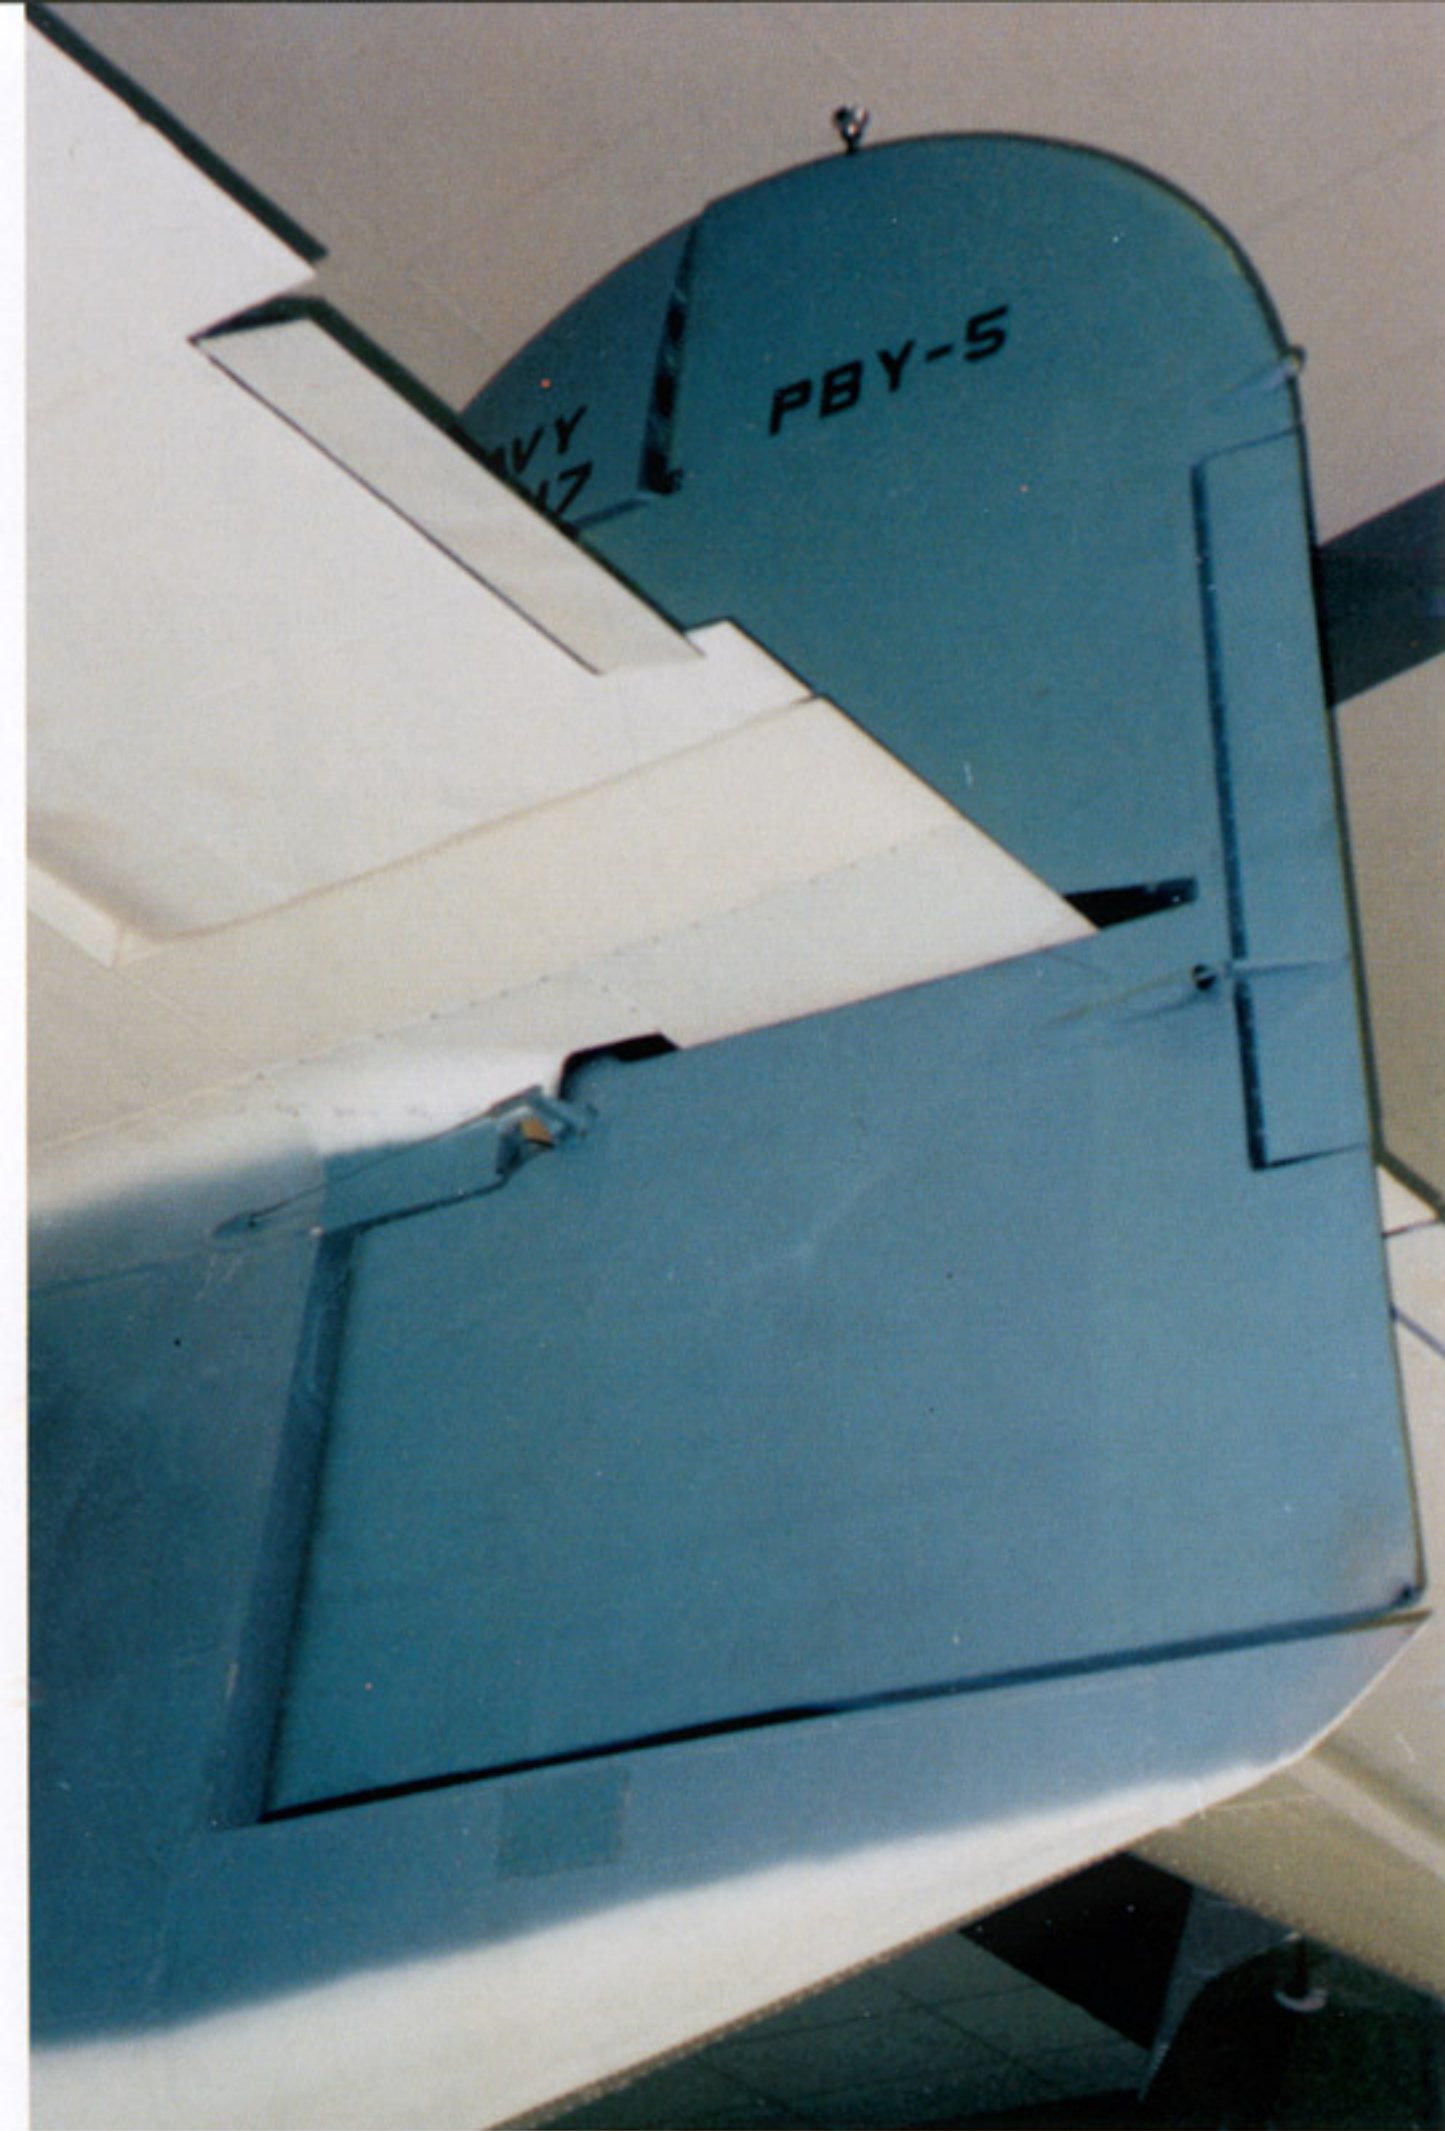
The fin and rudder of the PBY-5 on display at the National Museum of Naval Aviation. The trim tab actuator was only on this side. Both elevators were also equipped with trim tabs. (WES)

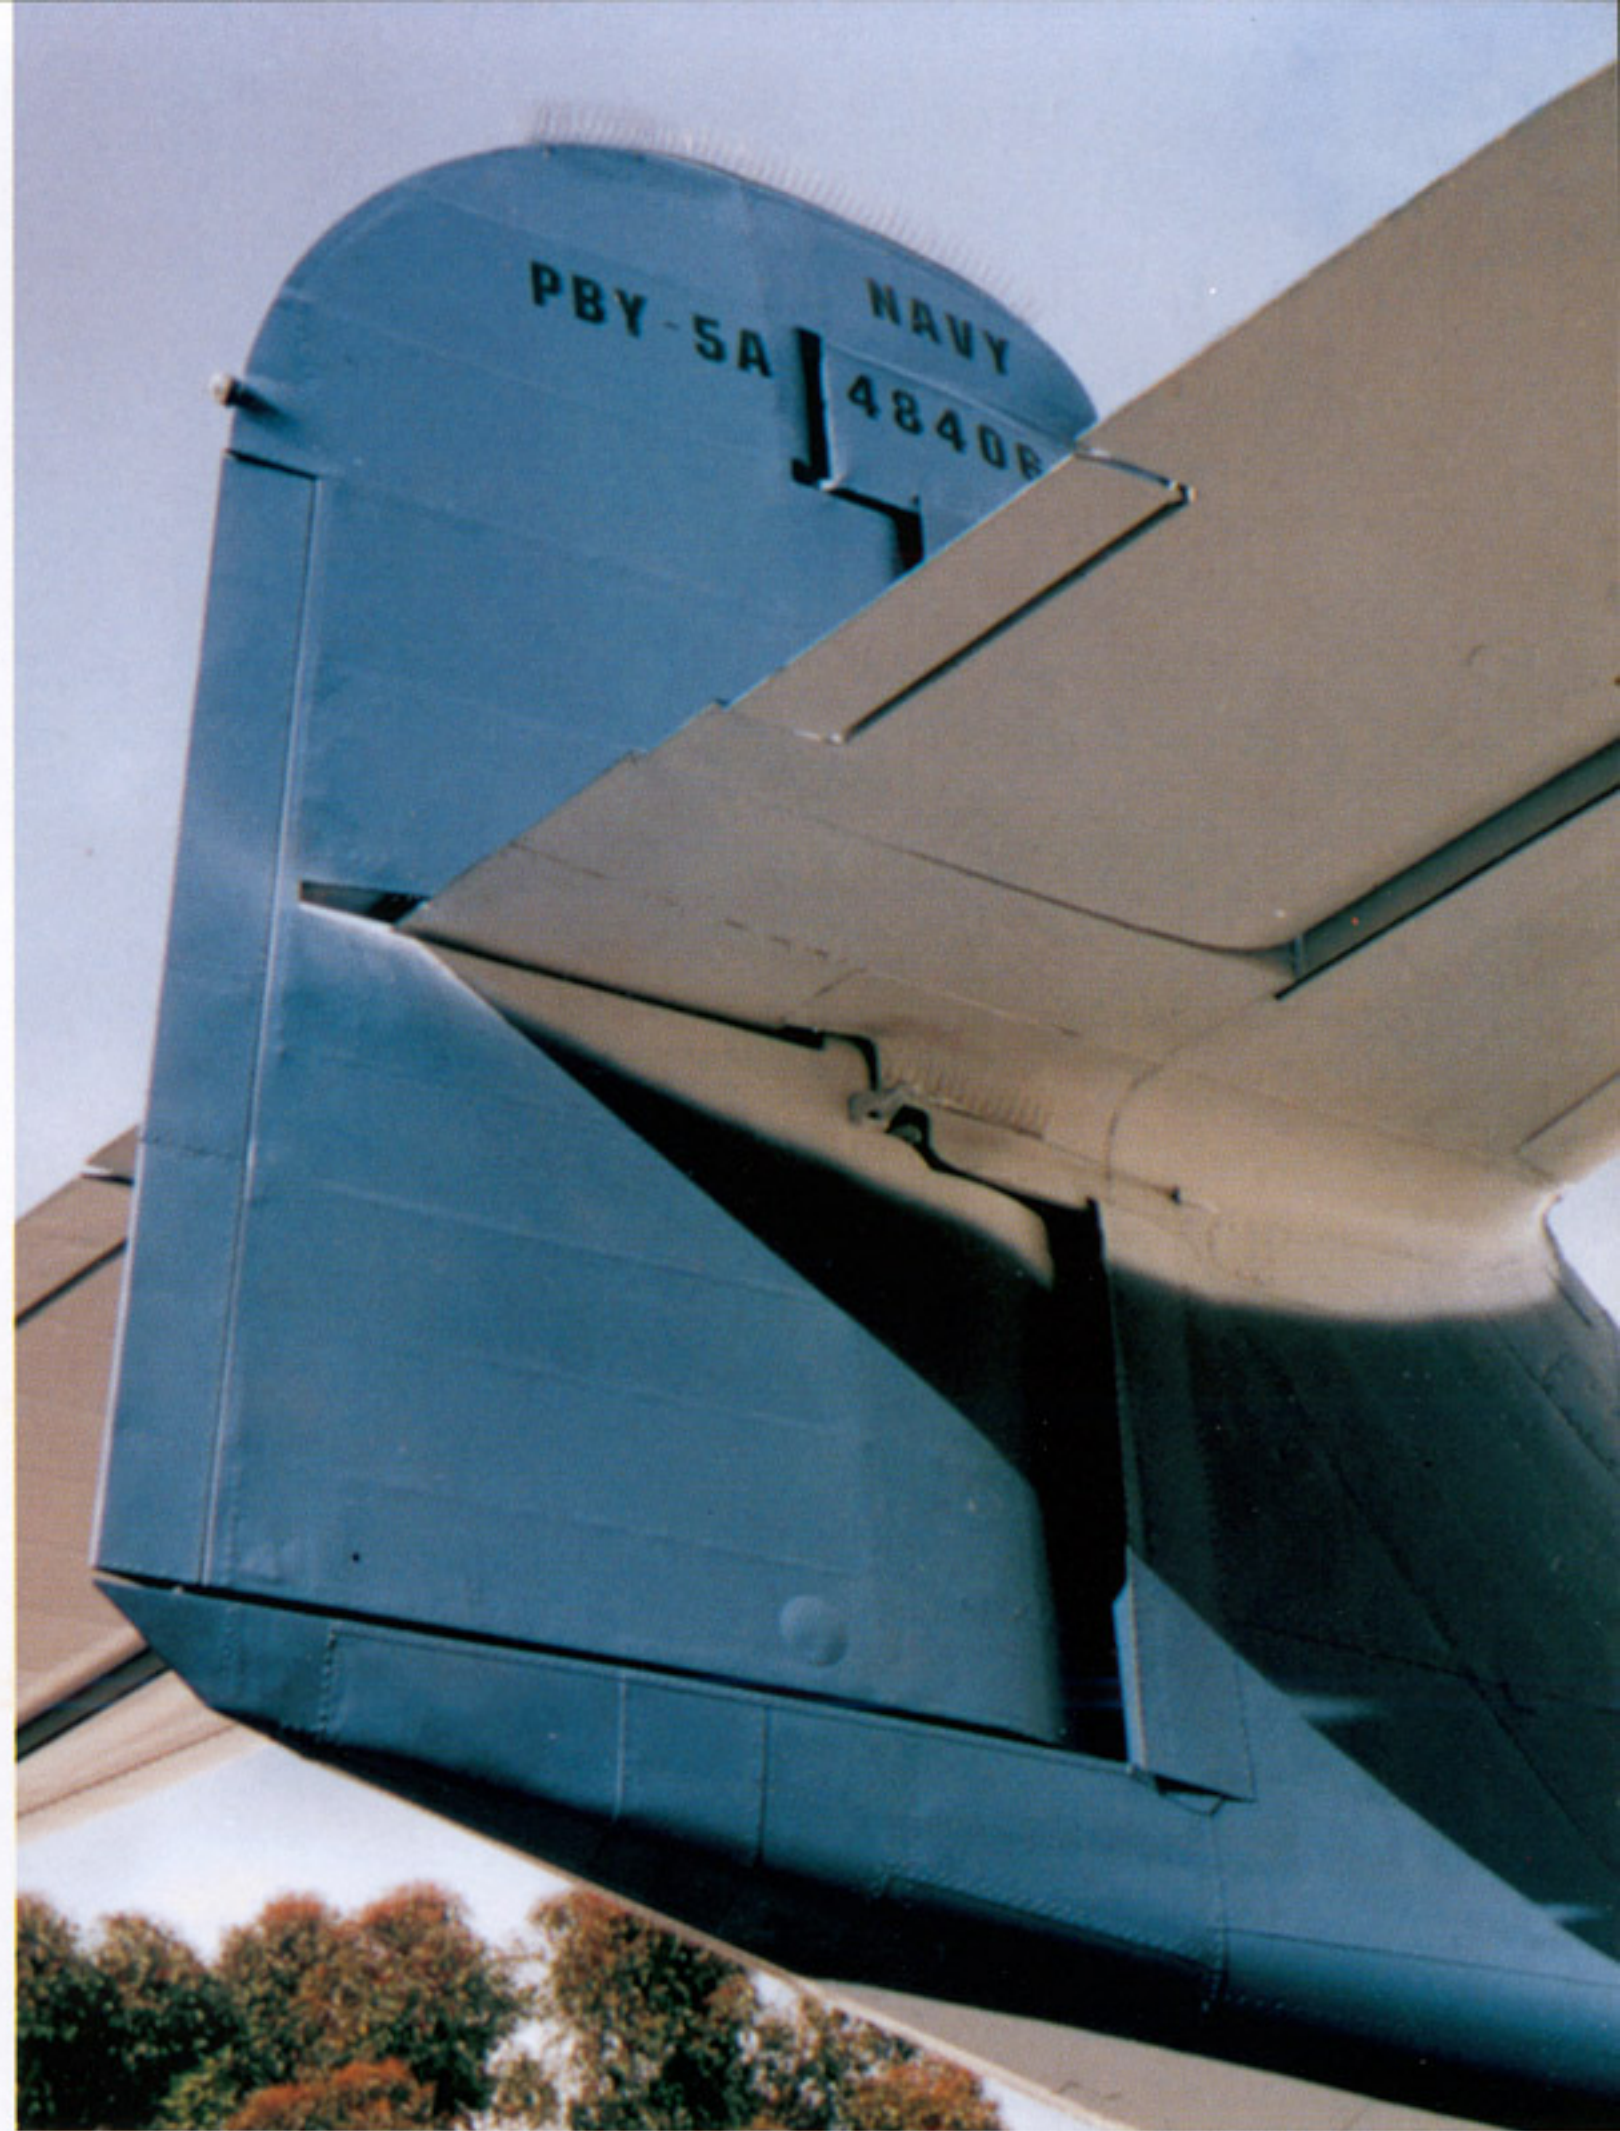
The vertical and horizontal tail, control surfaces and trim tabs of the San Diego Aerospace Museum's PBY-5A. The rudder control cable and control horn are visible just below the horizontal tail. (Richard Dann)
